Some proposals for Arudj Cathedral: from diagnosis to static consolidation

Lorenzo JURINA,¹ Christian AMIGONI

The study case of Arudj Cathedral

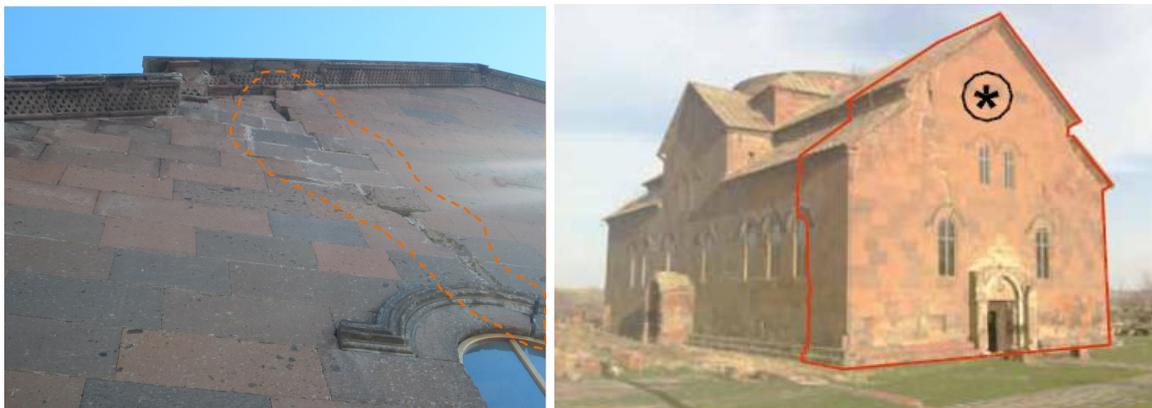
Overturning of the gable, thrust of arches and vaults on lateral structural elements and weak connections of the principal façade were the mainly global mechanisms detected.

Fig 2: Results the visual inspection phase

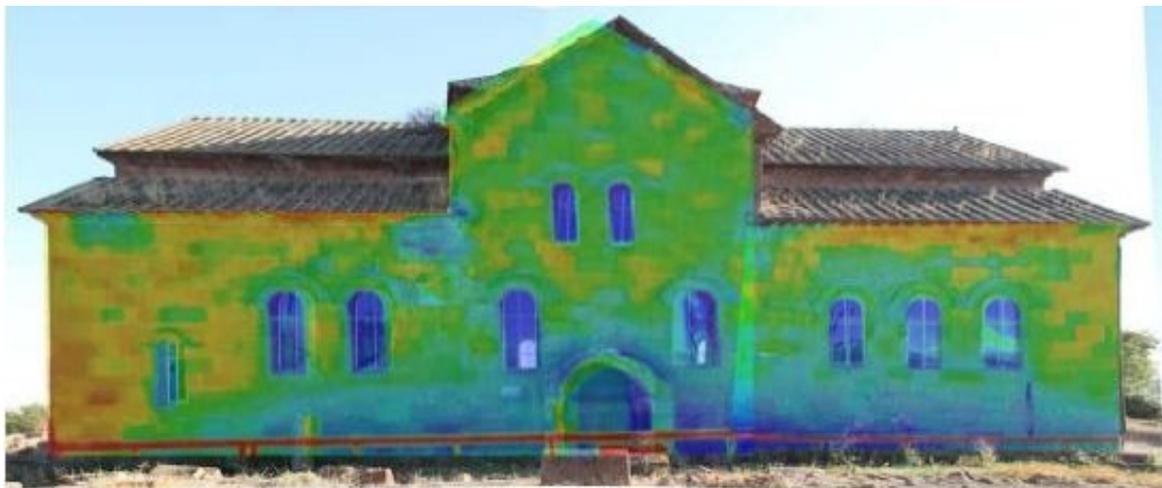
All the masonry walls were analyzed to understand their internal geometry and to verify the presence of voids and humidity, which possibly caused degradation in strength.

Fig 3: thermography of lateral front

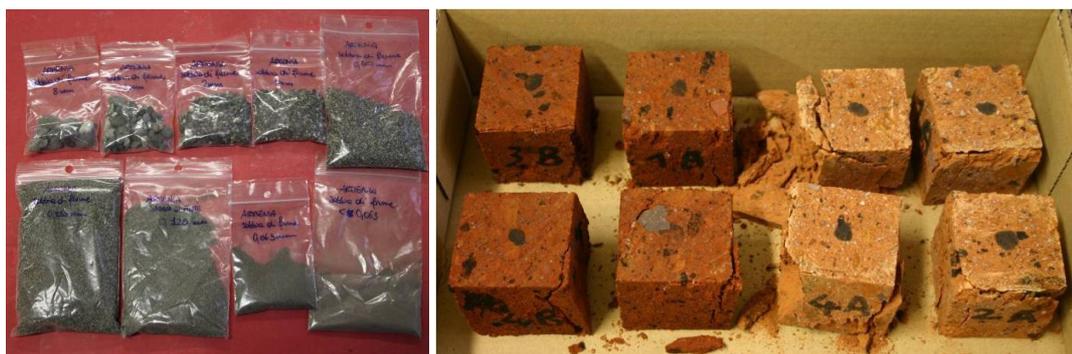
All the results obtained through in situ tests, as thermography and sonic, were efficiently supported by laboratory tests conducted on stones and mortar, in order to evaluate their chemical and mechanical properties

Fig 4: Samples of mortar and stone taken from the Cathedral
