Structural identification through dynamic tests on historic buildings: some experiences

I. A NEW STRUCTURAL STAIR FOR THE CONSOLIDATION OF TORRE GORANI - MILAN

II. THE CASE OF COLORNO CATHEDRAL

III. DYNAMIC TESTS FOR CALIBRATING THE NUMERICAL MODEL OF PALAZZO DELLA RAGIONE IN MILAN

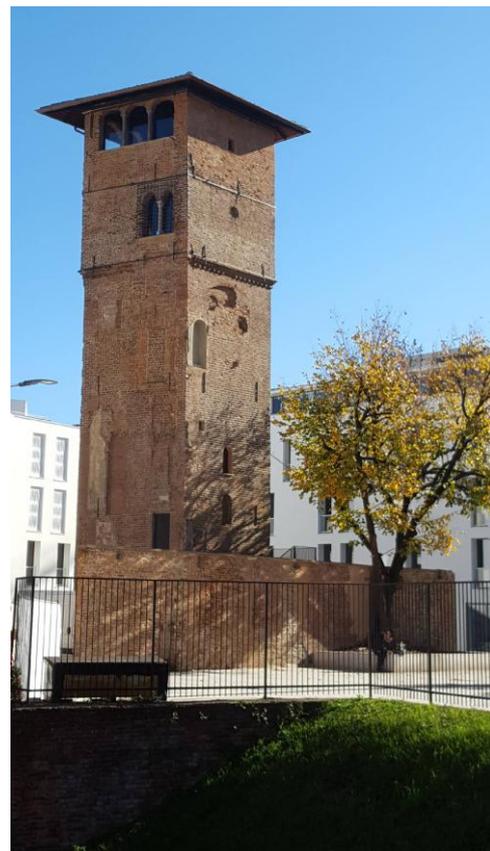
Fig. 1. Gorani Tower in Milan, after the restoration works.

In the case of Gorani Tower in Milan the new stair plays a decisive structural role, becoming the backbone of the tower. Along a convoluted vertical path, the stair is intertwined with five inclined steel tube, that support the stair and (by means of 16 vertical cables hanged to the top deck and parallel to the walls) "take over" a portion of the self-weight of the masonry walls, removing a percentage of the vertical loads.

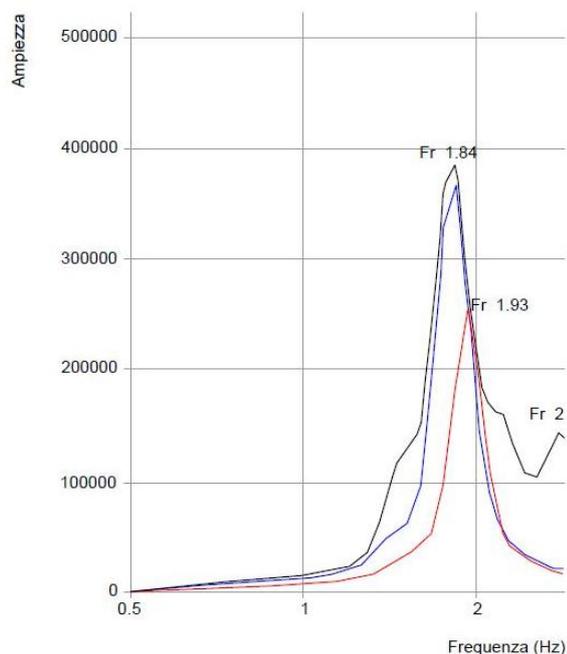
Fig. 2. Increase in frequencies and reduction in amplitudes experimentally recorded. Situation pre-intervention (blue and black lines) and consolidated situation (red line)

Analyzing the outcome of the tests, improvements were recorded both in terms of frequency and amplitude.

In fact, a rise in frequency was detected, due to the mutual connection between masonry and steel (partly mitigated by the mass increase of approximately 11.5 tons of steel added to 340 tons of masonry).

The increase was about 10%, varying from 1.84 Hz to 1.93 Hz in the north-south direction and 1.47 Hz to 1.51 Hz in the east-west direction.

With regard to the amplitude, compared with the displacement of the mixed tower + scale system, a decrease of 31% in the north-south direction and 46% in the east-west direction was obtained. The contribution in the east-west direction was more consistent due to the dissymmetry of the new scale, which results in greater rigidity in the north-south direction as planned at the design stage.

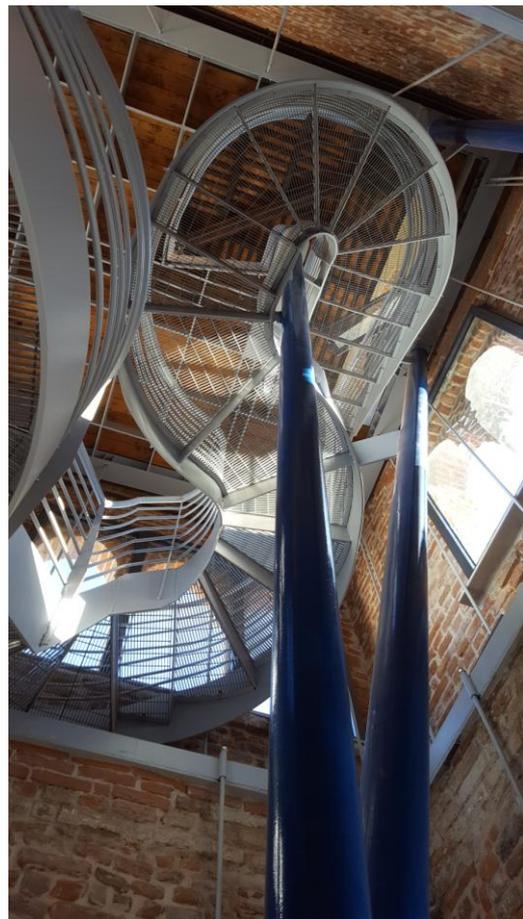
Fig. 3. The new steel stair in Gorani Tower

The new steel ladder offered the tower a beneficial contribution also in terms of horizontal displacements at the top, which in the most severe situations were reduced by 48% in the event of wind and 30% in the seismic case, ensuring more than acceptable values, lower than H / 1000.

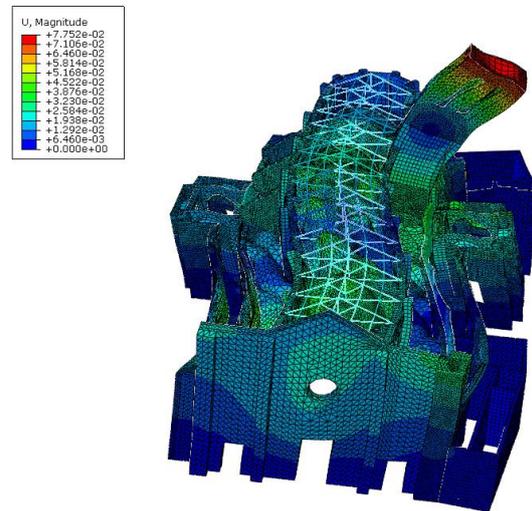
Fig. 4. The numerical FE model of the Cathedral

The comparison between numerical results (obtained from FEM modeling) and the results of experimental measurements in terms of their own frequencies and modes have returned more than acceptable resemblances. In a second time, some consolidation interventions were

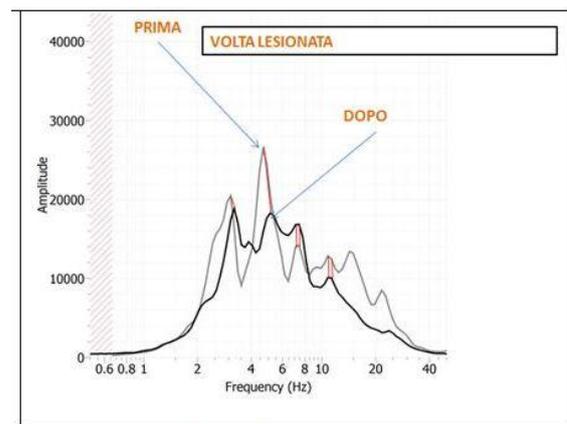
Fig. 5. Experimental frequencies pre and post consolidation intervention on the vaults

After the consolidation interventions, an “ex-post” dynamic diagnostic campaign was conducted to compare the new frequencies with the previously measured ones and with the numerical results. Concerning the vaults, repetition of measurements identified a shift of frequencies to higher values, in the consolidated situation, as shown in Fig. 5. Even the maintenance of the spectral form pre and post-intervention must be highlighted.

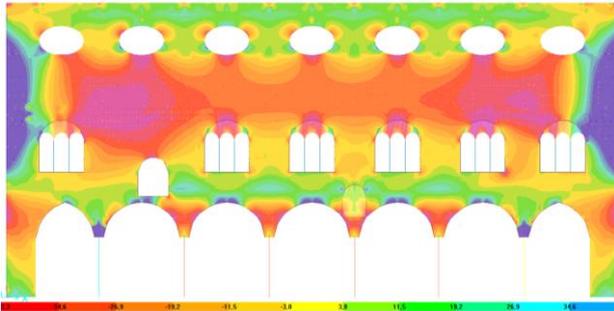
Fig. 7. Numerical state of stress of the Palace, obtained through the calibrated model.

Using an iterative procedure and calculating the M/R ratio (Mass/stiffness) for various values of the elastic modulus, a "calibrated" elastic modulus of $E = 1373$ N/mm² was obtained, with a difference from the module detected by flat in the order of 8.47%, that is an acceptable value.

By inserting this "calibrated" elastic modulus into the FEM model, a first frequency $f_1 = 1.35$ Hz was obtained, which is a value not far from the experimental data.

With this "calibrated" elastic module, the stresses and deformations of the global model were subsequently calculated.

In addition, the modal deformations obtained from the FEM model respect the phases and counter phases highlighted by on-site dynamic surveys, conducted to obtain the own frequencies of the building by measuring environmental microtremors.

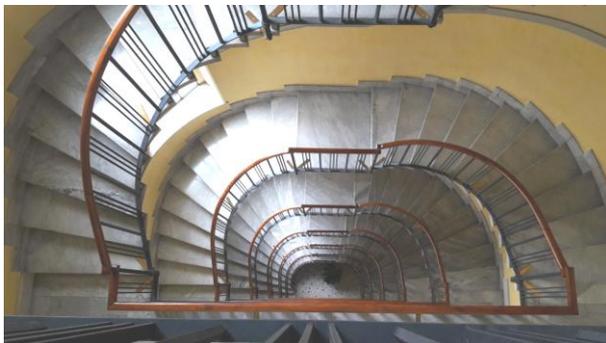
Fig. 8. View of the investigated marble stair

The staircase of the building was constructed with monolithic stone elements (in the case of white marble with gray grain type "Arabescato") inserted directly into the perimeter masonry, with a static shelf scheme. The thickness of the planks was only 6 cm.

During the first inspections, three different degradations were observed. The first consisted in a cracking pattern on a staircase wall. The cracks were wider and more frequent at the top of the compartment and were inclined by about 45°, a trend which suggests the differential lowering of a masonry portion.

The other two structural degradations observed directly affected the slabs of the stairs and consisted in a misalignment of certain elements (manifested by the presence of detachments between the lifting and pedestrian elements) and the presence of cracks affecting several lifting plates in the ramps, in the higher floors.

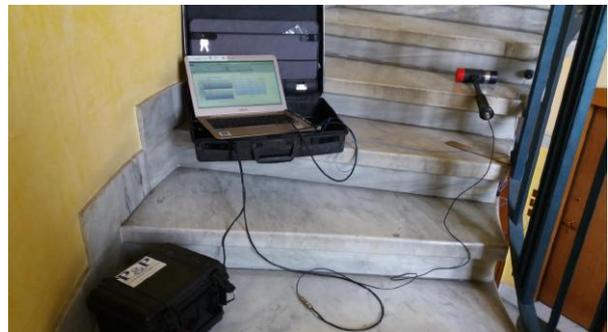
Fig. 9. Instruments adopted for dynamic tests

In particular, local dynamic surveys were performed, by measuring the own frequencies of vibration of all treads, recording with some triaxial accelerometers positioned on the individual elements.

Accelerometric measurements applied to individual marble shelves, excited with an instrumented hammer, allowed to catalog all the elements according to the first recorded vibration frequency, thus distinguishing three subgroups:

- 74 elements characterized by a high frequency (> 80 Hz);
- 75 elements characterized by a mean frequency (50 < Hz < 80);
- 9 elements characterized by a low frequency (< 50 Hz).

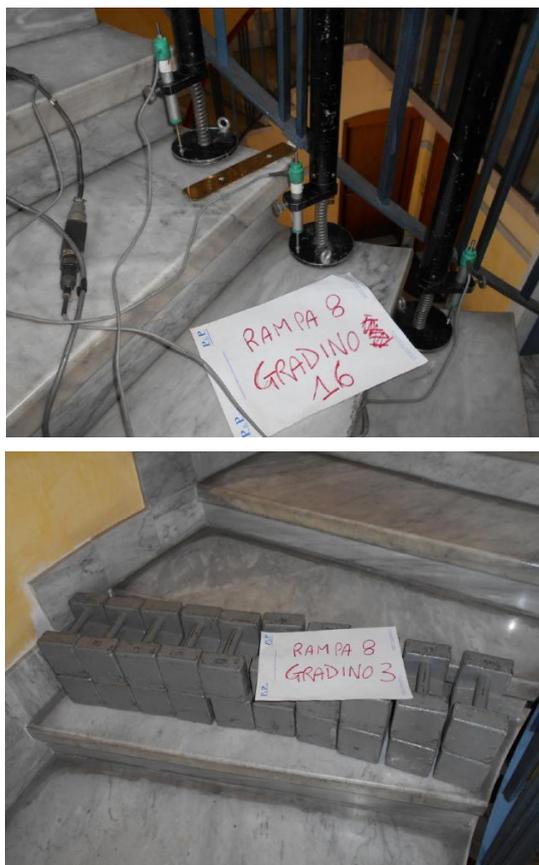
Fig. 10. Instruments adopted for load tests

Subsequent to the measurements of the frequencies on the 158 treads, seven load tests were conducted to determine the deformation of some of them. A distributed load was applied on the tread and the sag of the shelves was measured.

Three load tests were conducted on low frequency steps, two load tests on mid frequency and two on high-frequency treads.

The results of the load tests clearly showed a direct correlation between the measured frequency and the deformation obtained from the test. In fact, the elements

characterized by a high frequency (i.e. the most stiff and less damaged) have undergone a limited deformation, with a sag at about 0.05 mm, while the other loaded elements showed greater deformation, with displacements ranging from 0.11 to 0.26 mm, or from 2 to 5 times the previous one.
